Mining Management Plan 2018 Exploration

**Vista Gold Australia Pty Ltd
Mount Todd Gold Project**

Authorisation Number: 0331 - 04

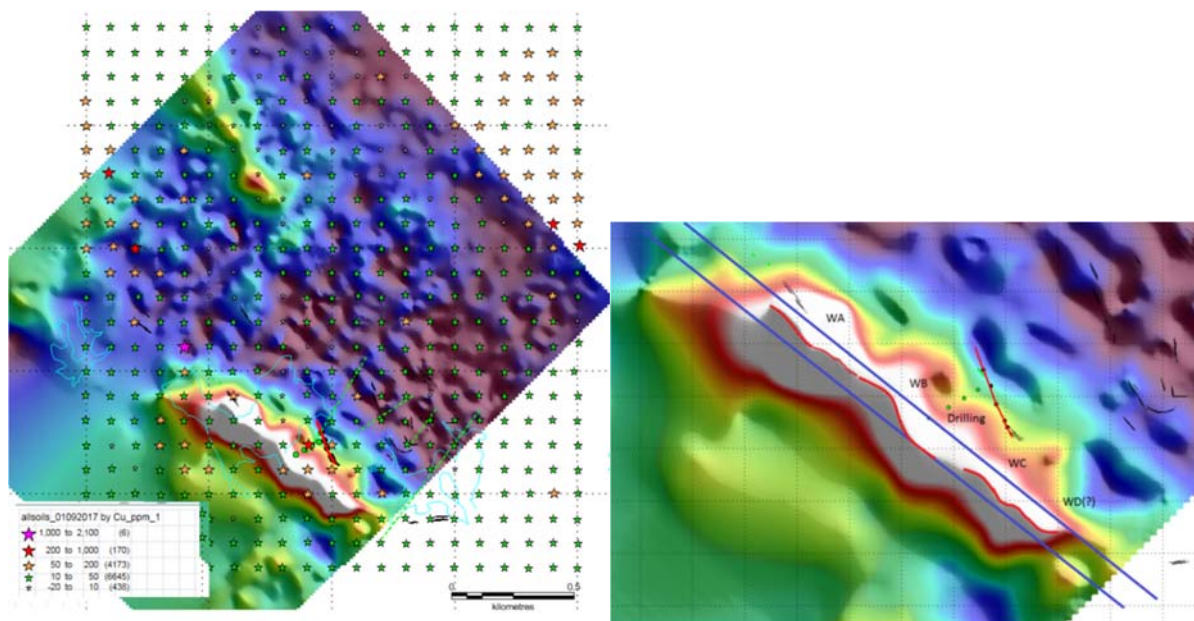
Figure 4 Resistance inversion of IP survey at Wandie, large southern target and smaller Northern Target with Cu soil assays overlain.

An IP survey was undertaken late 2017 to identify additional targets / the plunge direction at Wandie, this work has been successful in defining a strike continuity of 700m, with an apparent plunge to the south west, as identified by the mapping. The IP survey has shown that the anomaly proceeds to the west under cover and is perhaps best developed there.

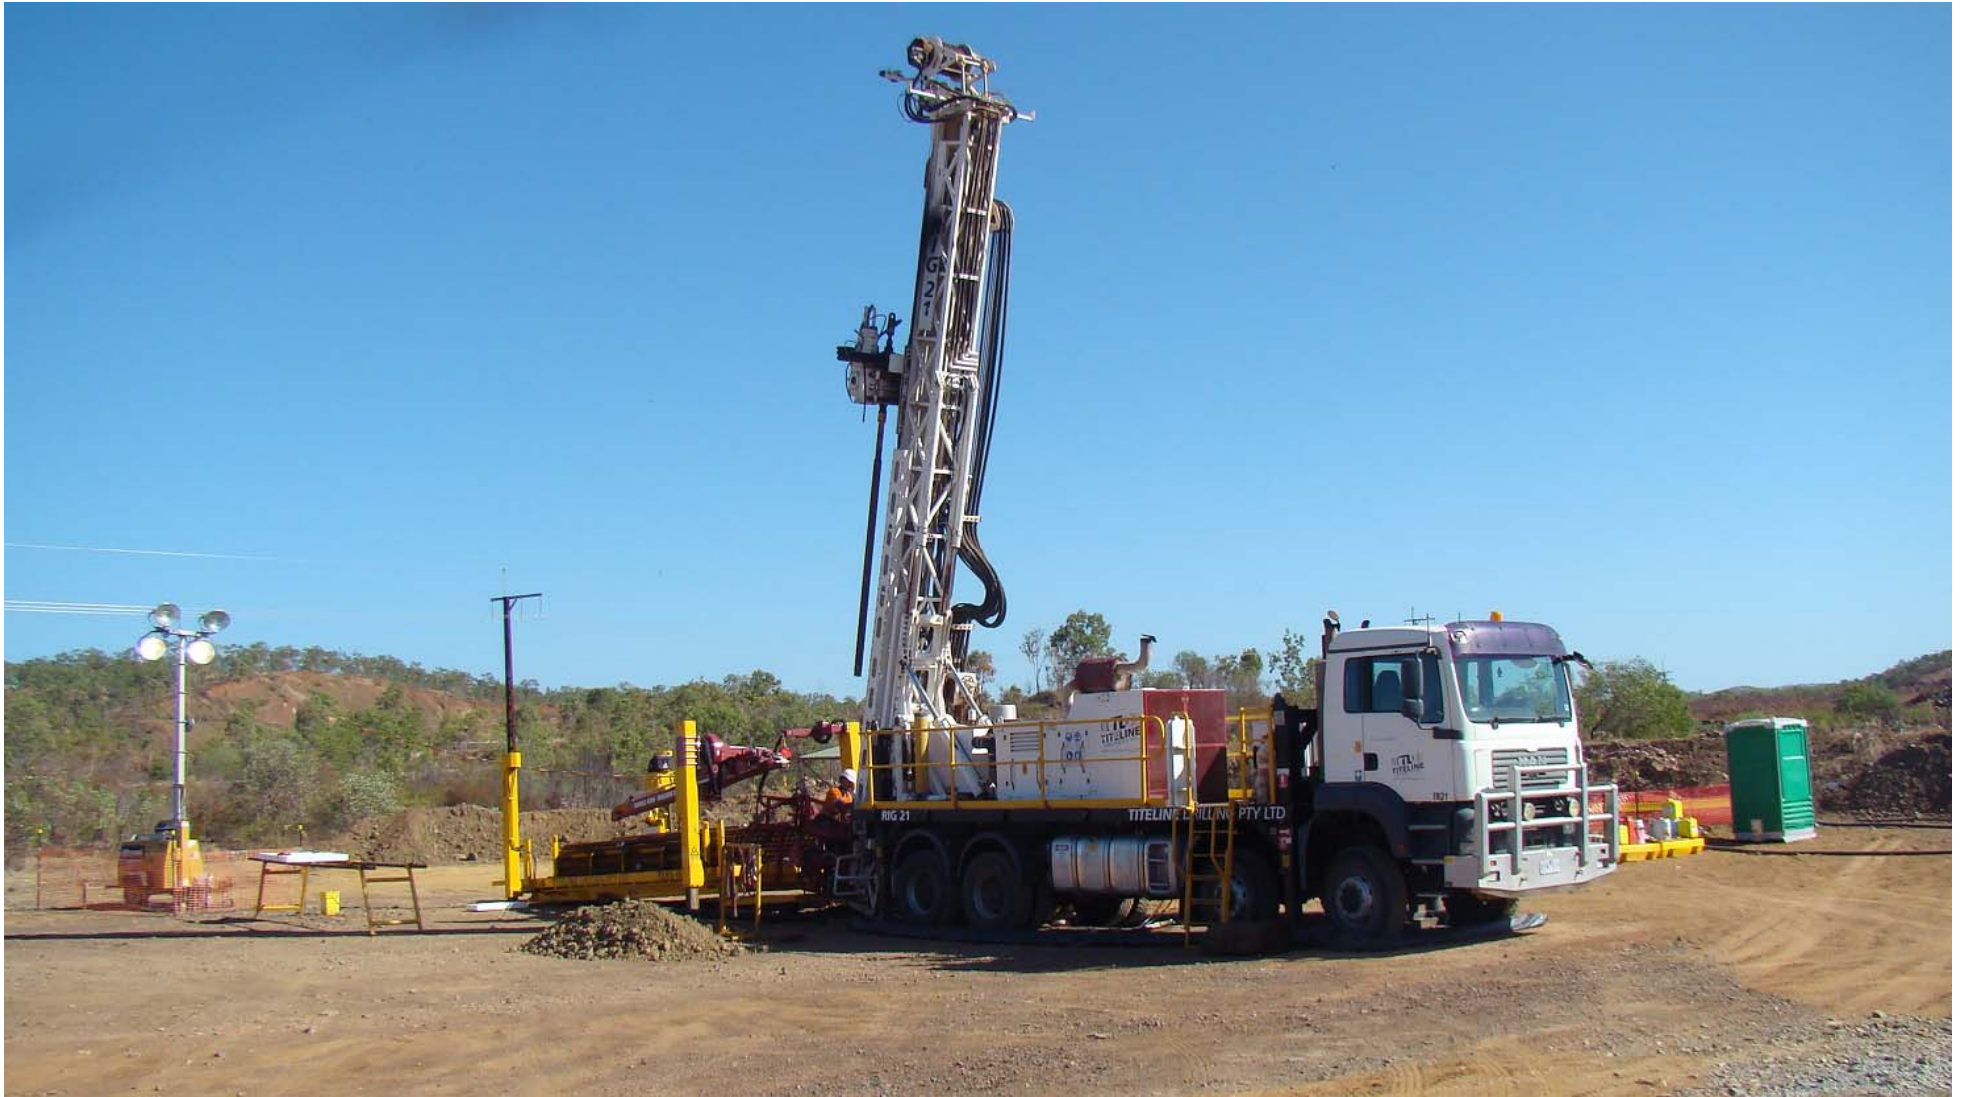
Figure 7 Drill Site setup NB Automated rod handler, which necessitates longer than usual drill-pad

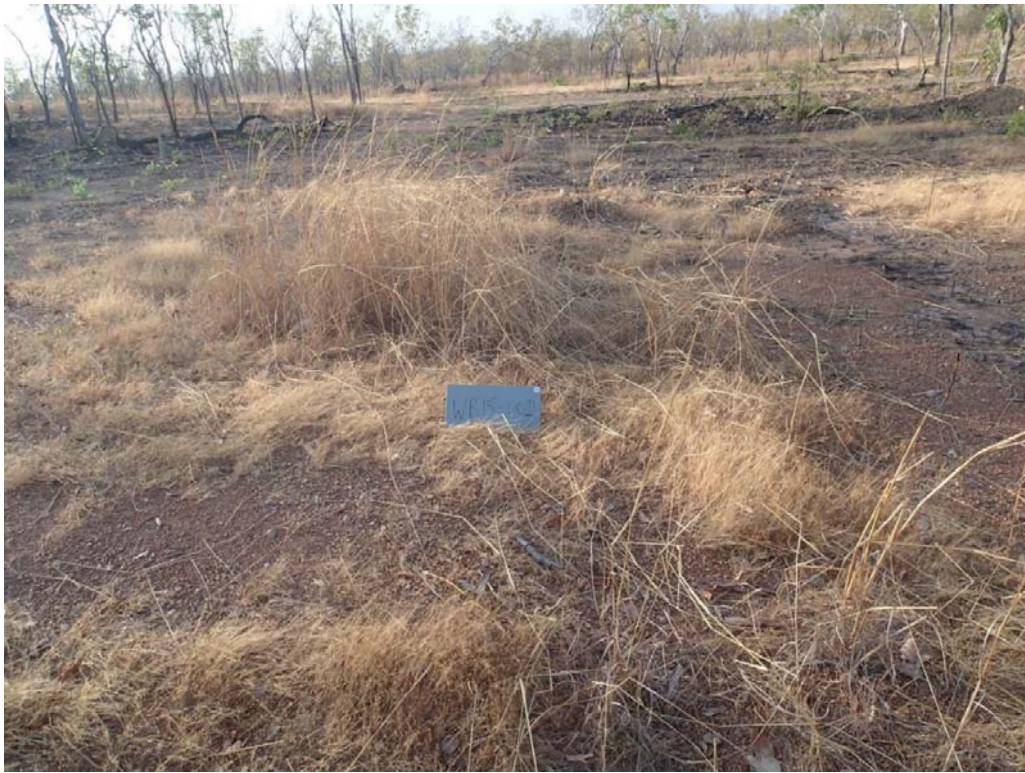
Figure 9 WB15-002 post rehab photo

Refund of bond is sought for 13 holes in total, 3 drilled at Snowdrop, 4 holes drilled at Wandie, 5 planned holes at Wandie that were not drilled and 1 planned hole at Snowdrop that also wasn't drilled. Please see below for example photos of rehabbed sites at Wandie and Snowdrop.

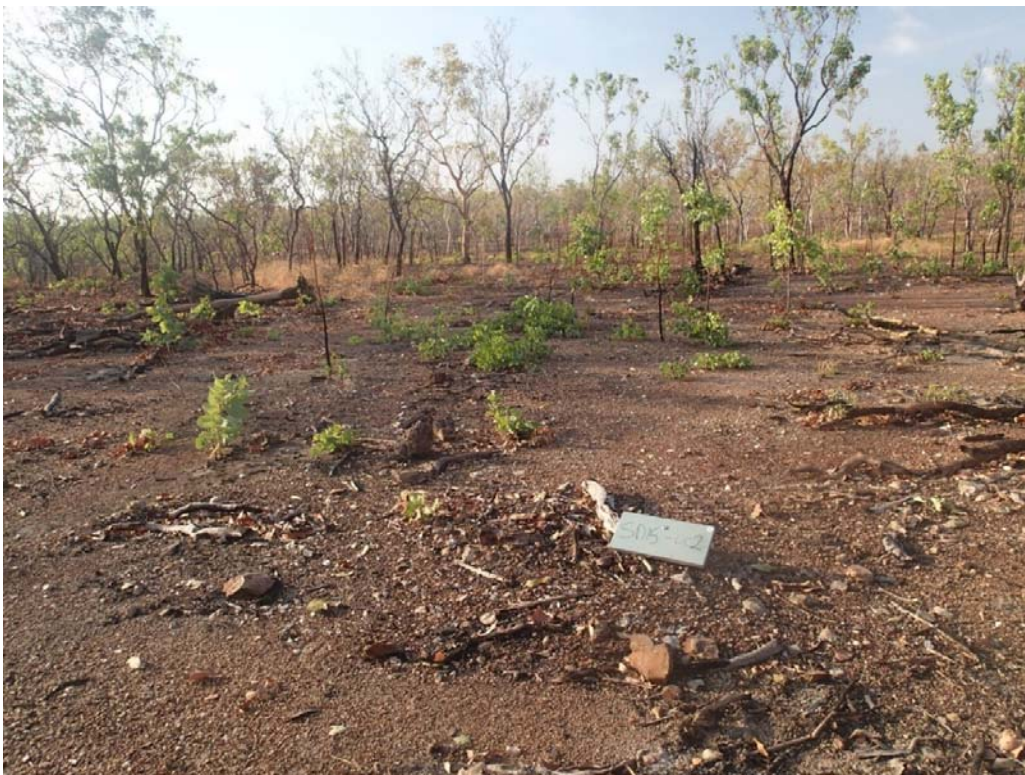
Figure 10 SD15-002 post rehab photo

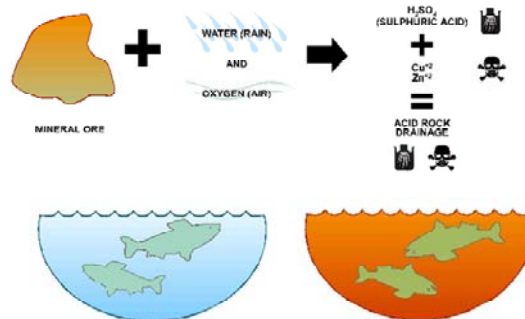
Acid Rock Drainage (ARD) Acid Mine Drainage (AMD)

Metal sulphides when exposed to air and water react to form sulphuric acid and dissolved metals

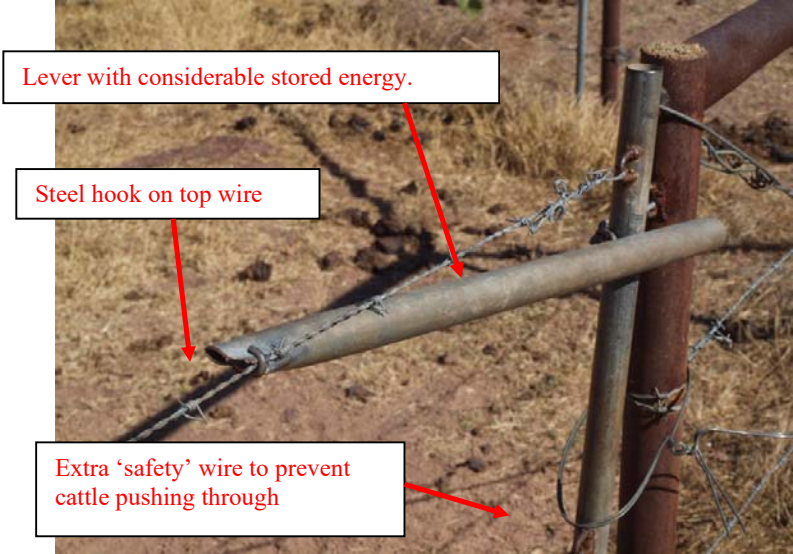
A "Cockie" or "Cloncurry" gate.

Cloncurry or cockies gates are used on the property and extreme care must be taken when opening and closing these gates as they can both cause injury and if not correctly shut, they can be opened by livestock.

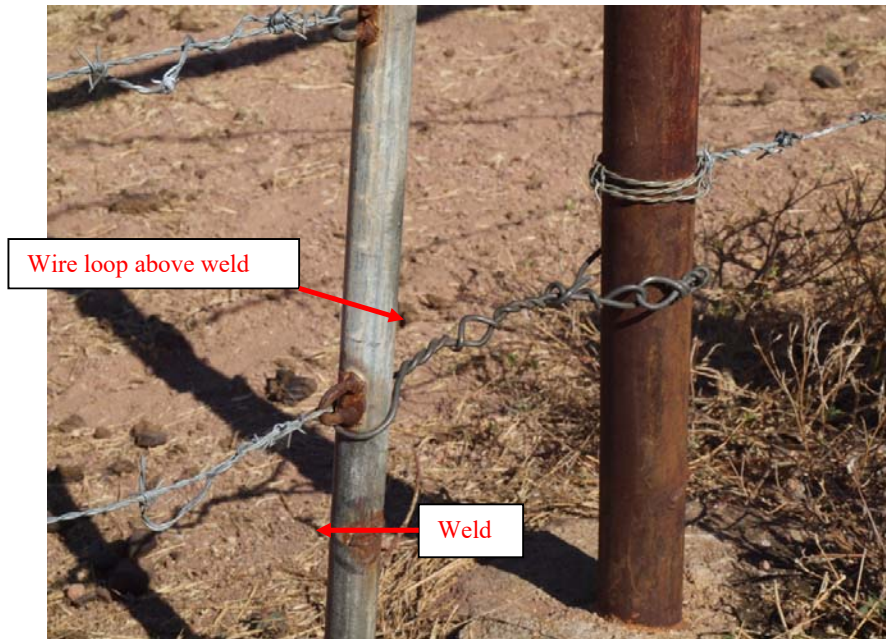
Close up of gate closing mechanism (lever under significant stored energy)

When opening a Cocky gate, be sure to keep the body out of harm's ways as there is considerable stored energy that if released in an uncontrolled manner will hurt!
