Mining Management Plan 2018 Exploration

**Vista Gold Australia Pty Ltd
Mount Todd Gold Project**

Authorisation Number: 0331 - 04

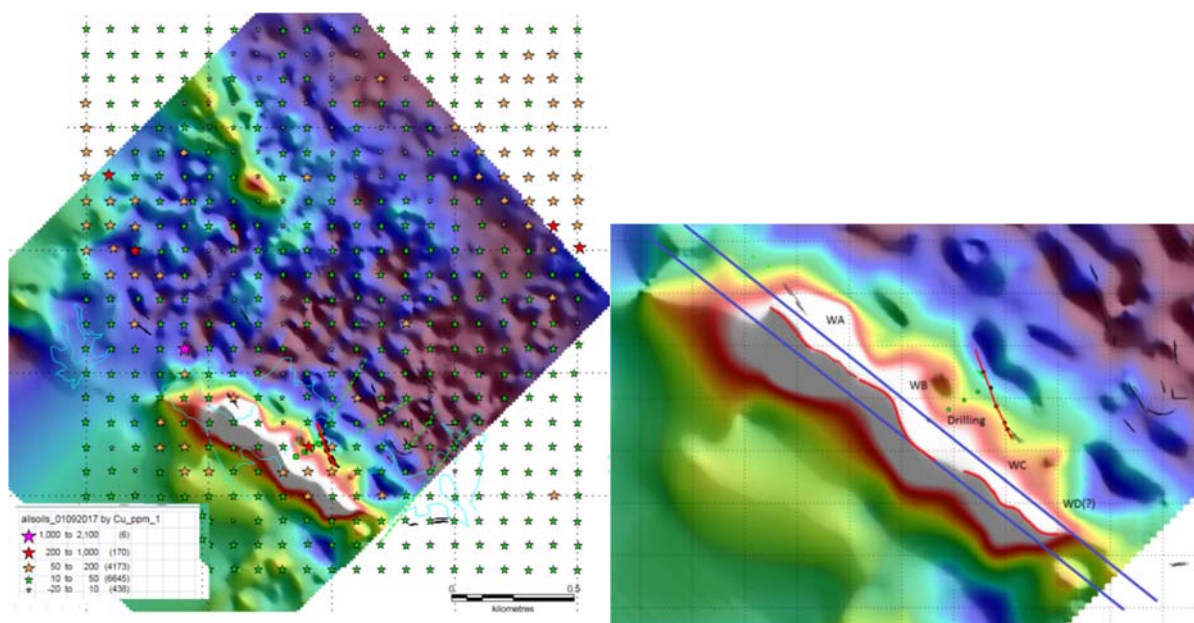
Figure 4 Resistance inversion of IP survey at Wandie, large southern target and smaller Northern Target with Cu soil assays overlain.

An IP survey was undertaken late 2017 to identify additional targets / the plunge direction at Wandie, this work has been successful in defining a strike continuity of 700m, with an apparent plunge to the south west, as identified by the mapping. The IP survey has shown that the anomaly proceeds to the west under cover and is perhaps best developed there.

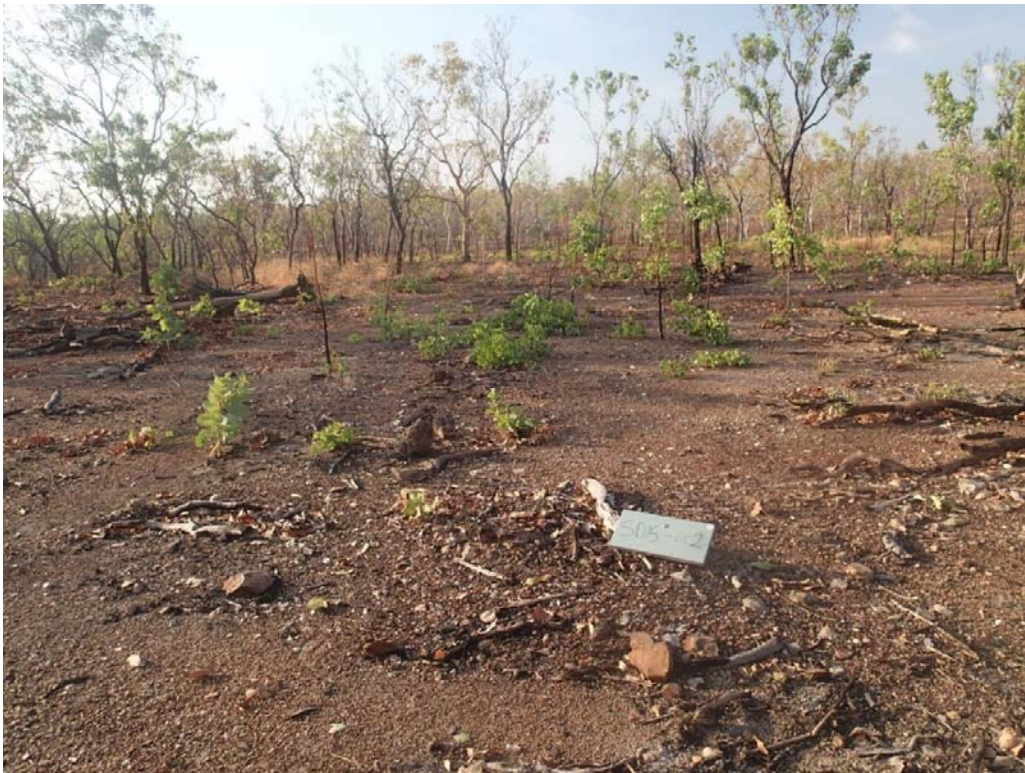
Figure 10 SD15-002 post rehab photo

Refund of bond is sought for 13 holes in total, 3 drilled at Snowdrop, 4 holes drilled at Wandie, 5 planned holes at Wandie that were not drilled and 1 planned hole at Snowdrop that also wasn't drilled. Please see below for example photos of rehabbed sites at Wandie and Snowdrop.

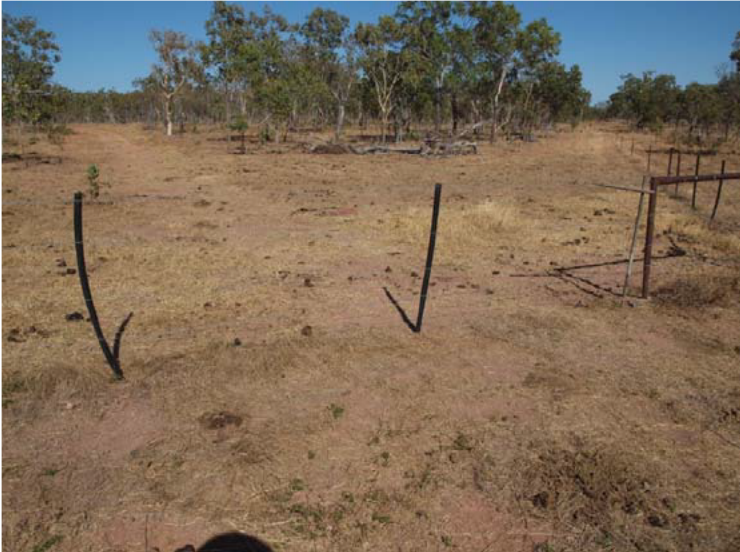
Cloncurry or cockies gates are used on the property and extreme care must be taken when opening and closing these gates as they can both cause injury and if not correctly shut, they can be opened by livestock.

A “Cockie” or “Cloncurry” gate.

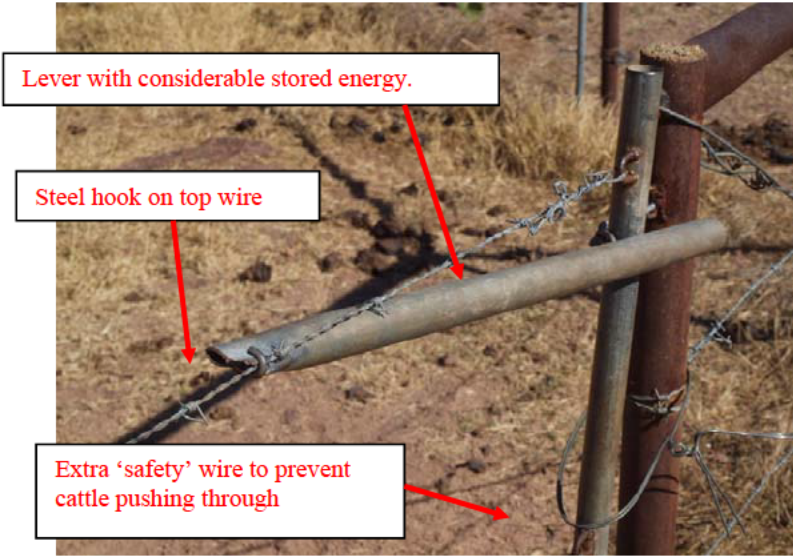
Close up of gate closing mechanism (lever under significant stored energy)

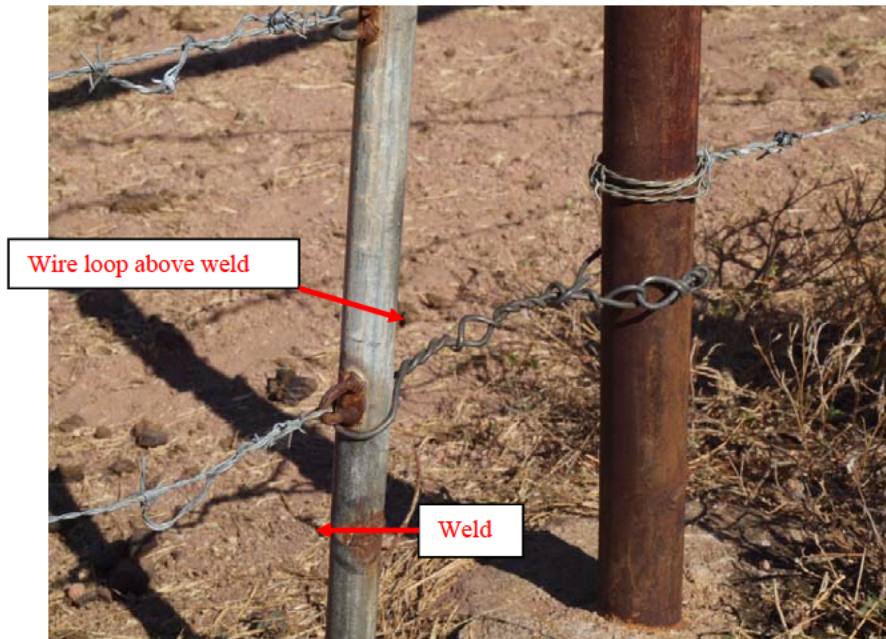
Wire loop at base of gate to prevent cattle pushing through. Ensure wire loop is fitted above weld on pipe.
