Mining Management Plan 2013 – 2017

Vista Gold Australia Pty Ltd

Mount Todd Gold Project

6 Water Management Plan

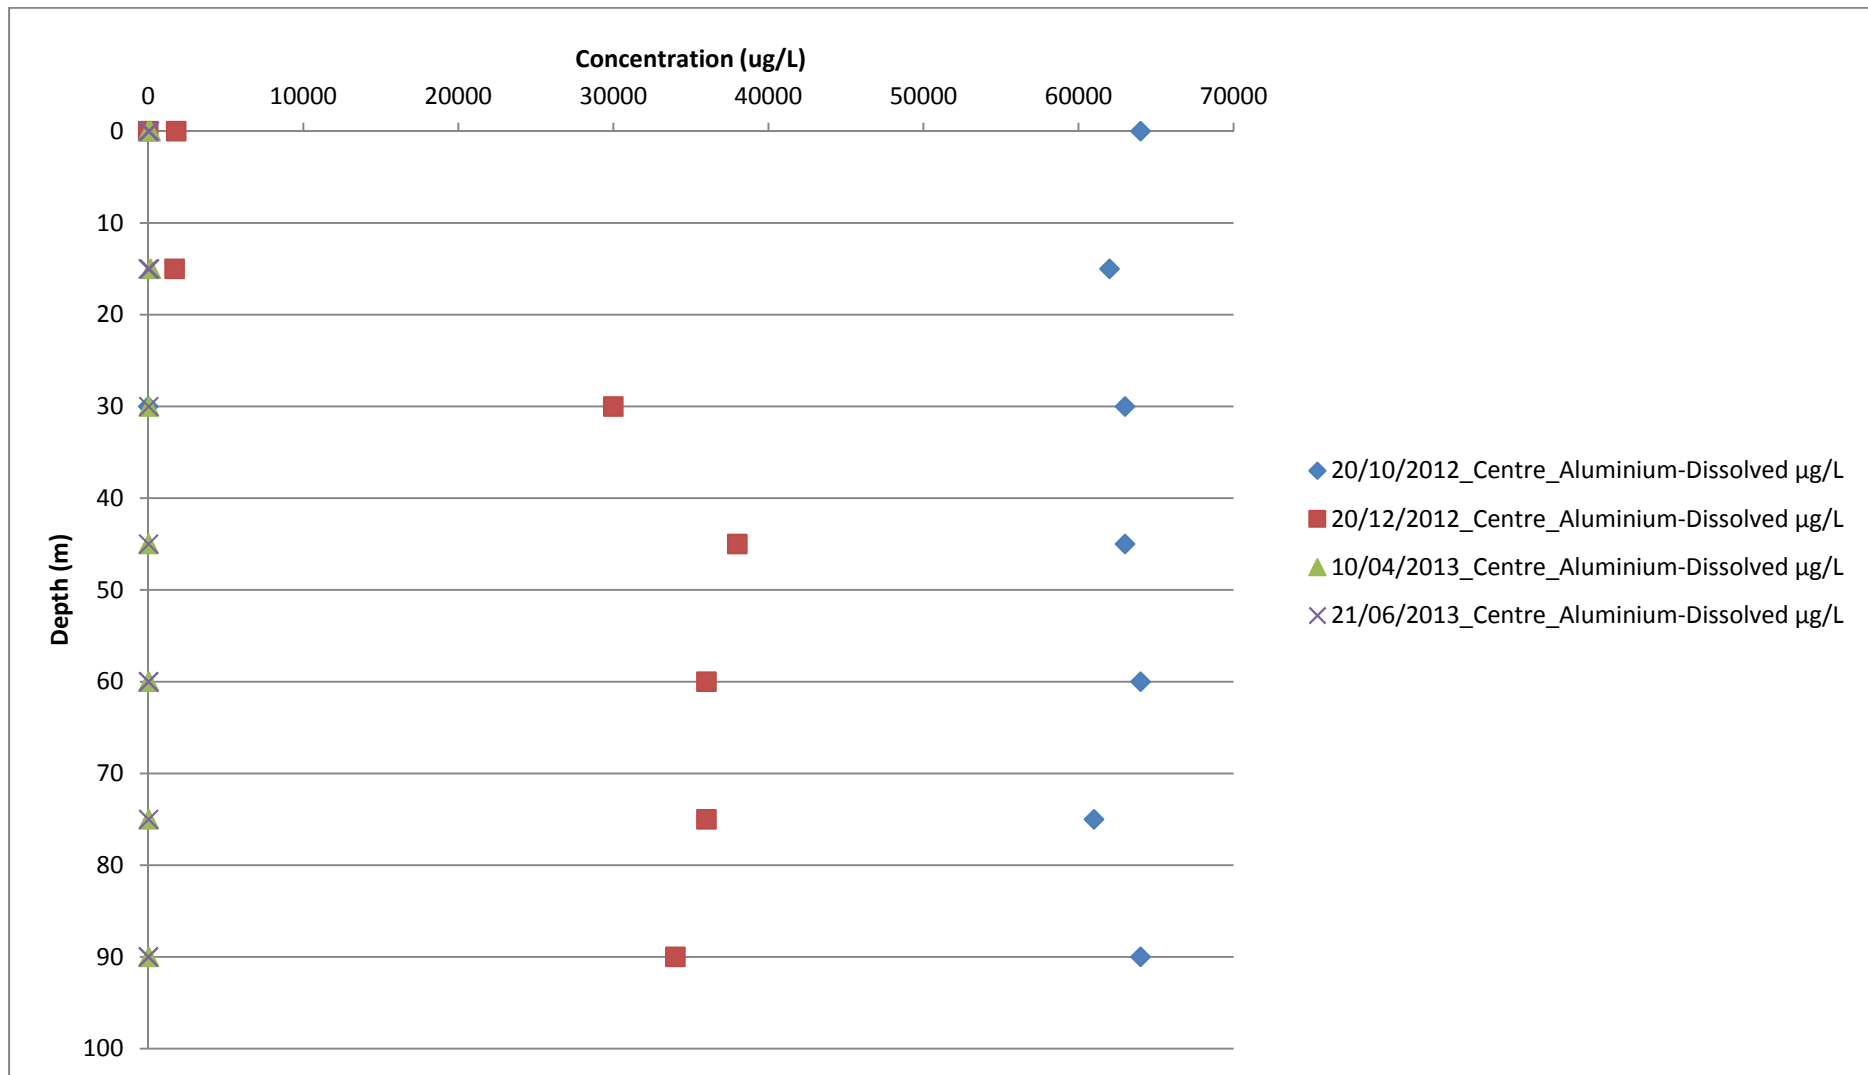
Figure 19 - Selection of 0.45um Filtered Aluminium concentrations over time vs depth

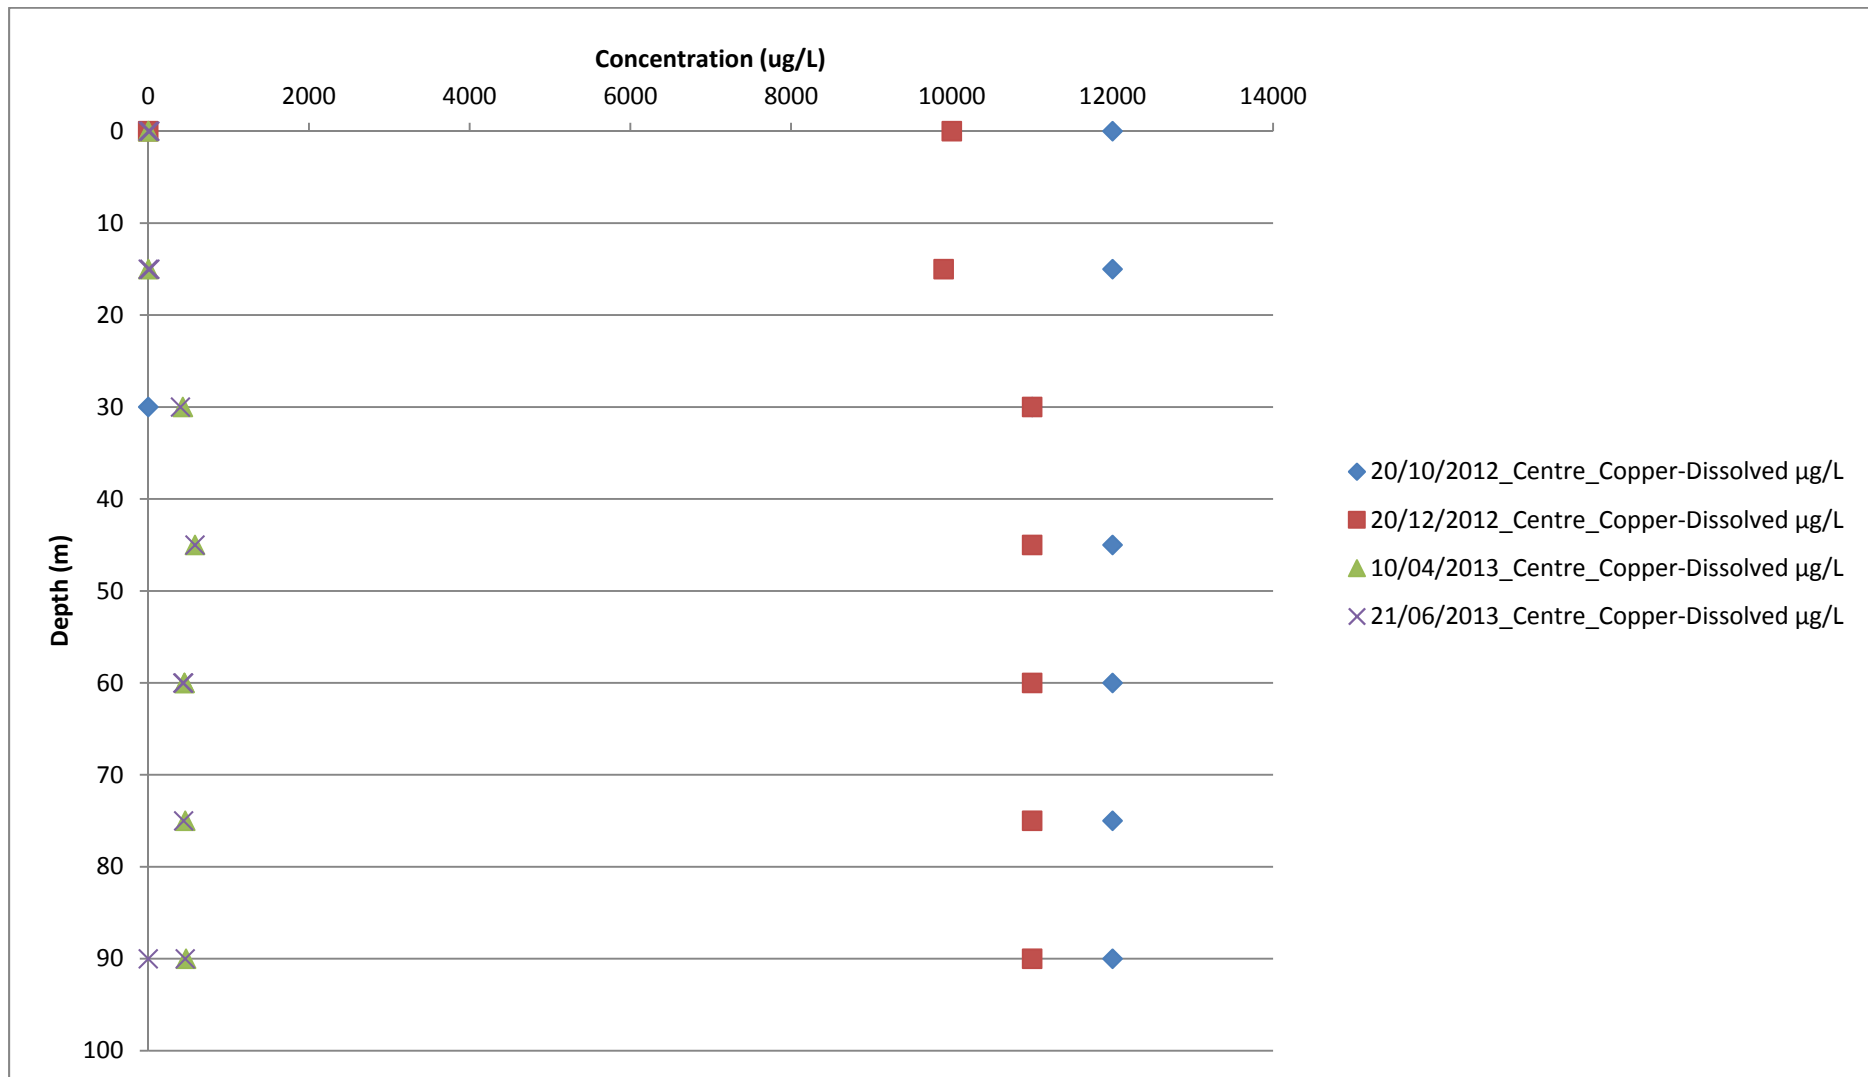
Figure 20 - Selection of 0.45um Filtered Copper concentrations over time vs depth
